# Residual Risk

## *An Account of Events in Nuclear Power Plants Since the Chernobyl Accident in 1986*

May 2007

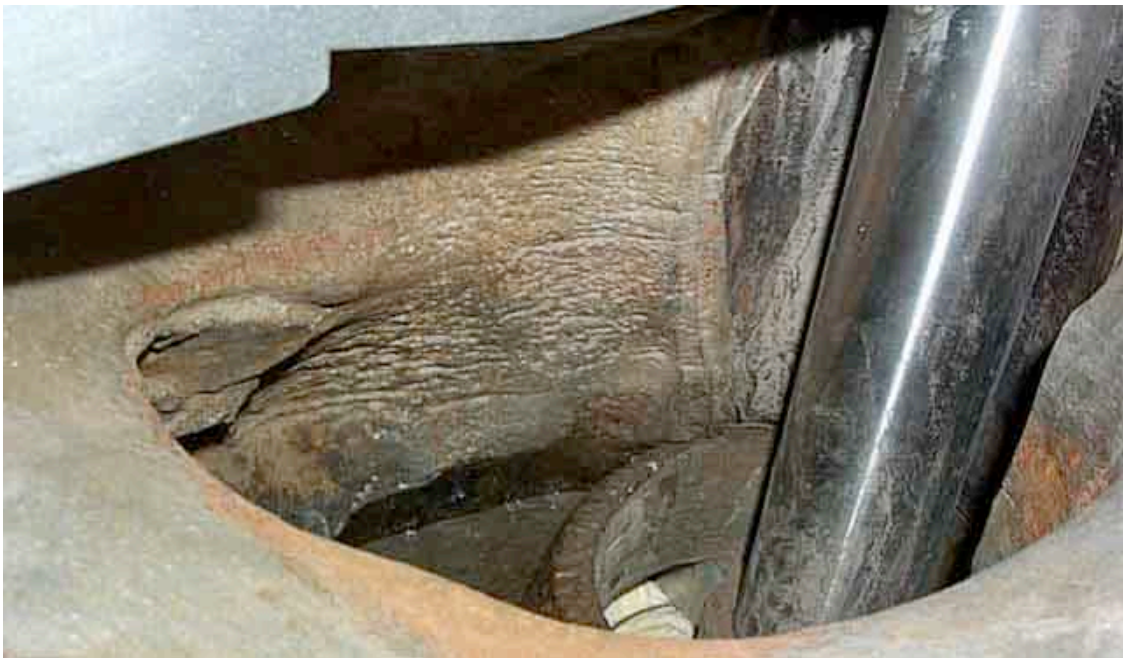
Had the 5mm stainless steel liner ruptured, a hole with a diameter of approximately 250mm would have created a medium-sized loss of coolant accident. While Davis-Besse was equipped with emergency systems to mitigate such an accident, these backup systems were also found to be impaired. The worst problem involved the containment sump used during the second phase of accident mitigation. In the first phase, emergency pumps transfer water from a large storage tank adjacent to the containment building into the reactor vessel to compensate for the cooling water pouring out the 250mm diameter breach. The water pouring out of the reactor drains to the bottom of the containment building where it collects in a concrete pit called the containment sump. Before the storage tank empties in about 30 to 45 minutes, the operators realign the emergency pumps to take water from the containment sump and send it to the reactor vessel. Workers found that the debris created by water jetting out through the hole (e.g., insulation and coatings scoured off piping and components) in addition to pre-existing debris inside containment (e.g., paint applied to the inner surface of the containment dome

*The large hole in the reactor vessel head around the vessel head nozzle.*
