# Residual Risk

## *An Account of Events in Nuclear Power Plants Since the Chernobyl Accident in 1986*

May 2007

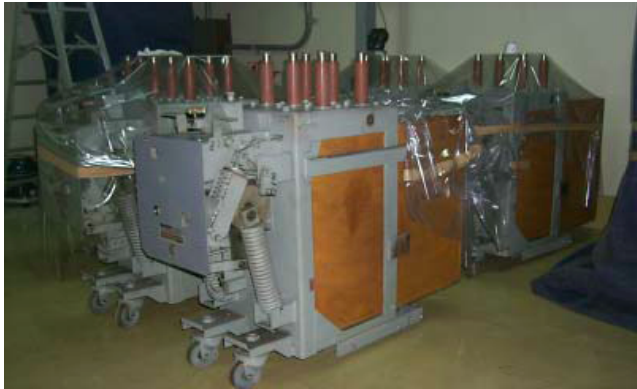
Normal Breaker

It turned out that the operator should have declared the event much earlier, as soon as the station blackout situation occurred. The breaker fault at the 4 kV essential bus is considered as the main cause of the event. The breaker and the switchgear got totally destroyed by the fire (see figure 11).

**Figure 11: Breaker Damage at Maanshan During Station Blackout**
